# Assessment of cercospora leaf spots development on sugar beet leaves by near infrared hyperspectral imaging

Ph. Vermeulen<sup>1</sup>, J.A. Fernández Pierna<sup>1</sup>, A. Tossens<sup>2</sup>, O. Amand<sup>2</sup>, P. Dardenne<sup>1</sup> and V. Baeten<sup>1\*</sup>  
<sup>1</sup>Walloon Agricultural Research Centre (CRA-W), Valorisation of Agricultural Products Department (D4), Food and Feed Quality Unit (U15), Henseval building - 24, Chaussée de Namur - 5030 Gembloux, Belgium  
 Corresponding author: baeten@cra.wallonie.be  
<sup>2</sup>SESVANDERHAVE N.V./S.A., 3300 Tienen, Belgium

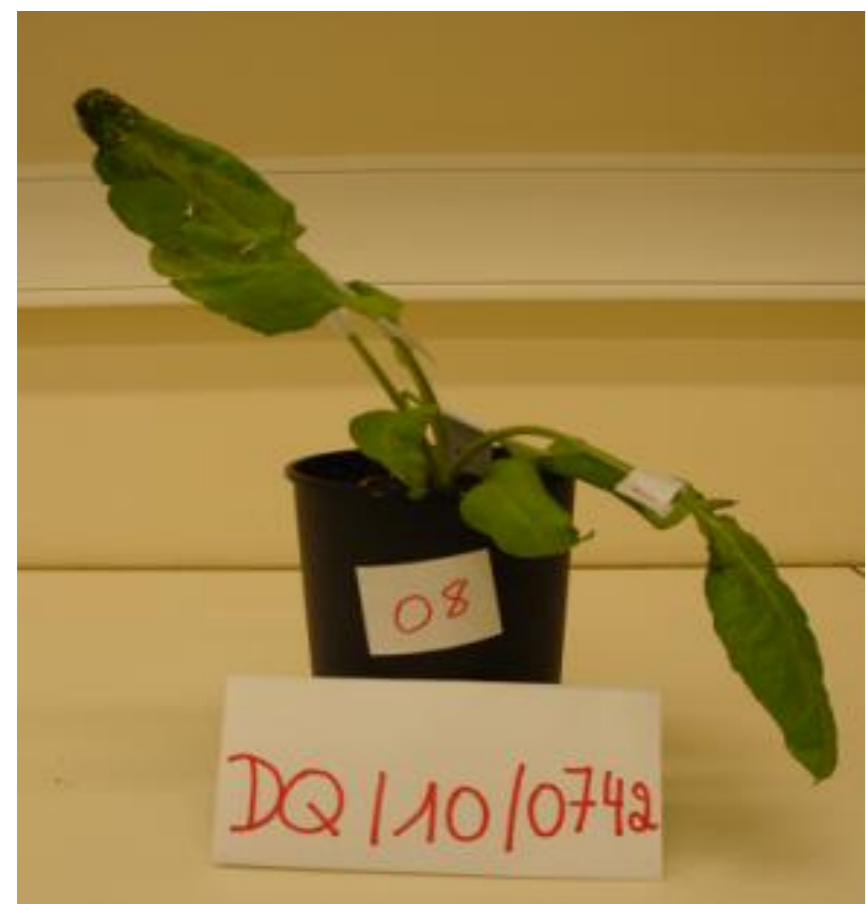
Figure 1: Cercospora susceptible plant at a early stage of the plant development.

For this experiment, 4 tolerant and 4 susceptible to cercospora leaf spot sugar beet plants were grown in plastic pots in a greenhouse (Figure 1). The plants were infected by spraying with cercospora beticola. Then, some leaves were analysed using a linescan NIR hyperspectral imaging system (Burgermetrics) during 6 days from the moment that the first symptoms were visible. This system includes a SWIR ImSpector N25E spectral camera from Specim Ltd, using a cooled, temperature stabilized MCT (Mercury-Cadmium-Telluride) detector, combined with a conveyor belt. All images consist of lines of 320 pixels that are acquired at 209 wavelength channels: 1100-2400 nm at 6.3 nm intervals with 32 scans by image. The acquisition is done using the software HyperPro (Burgermetrics). The samples are spread on the conveyor belt (Figure 2).

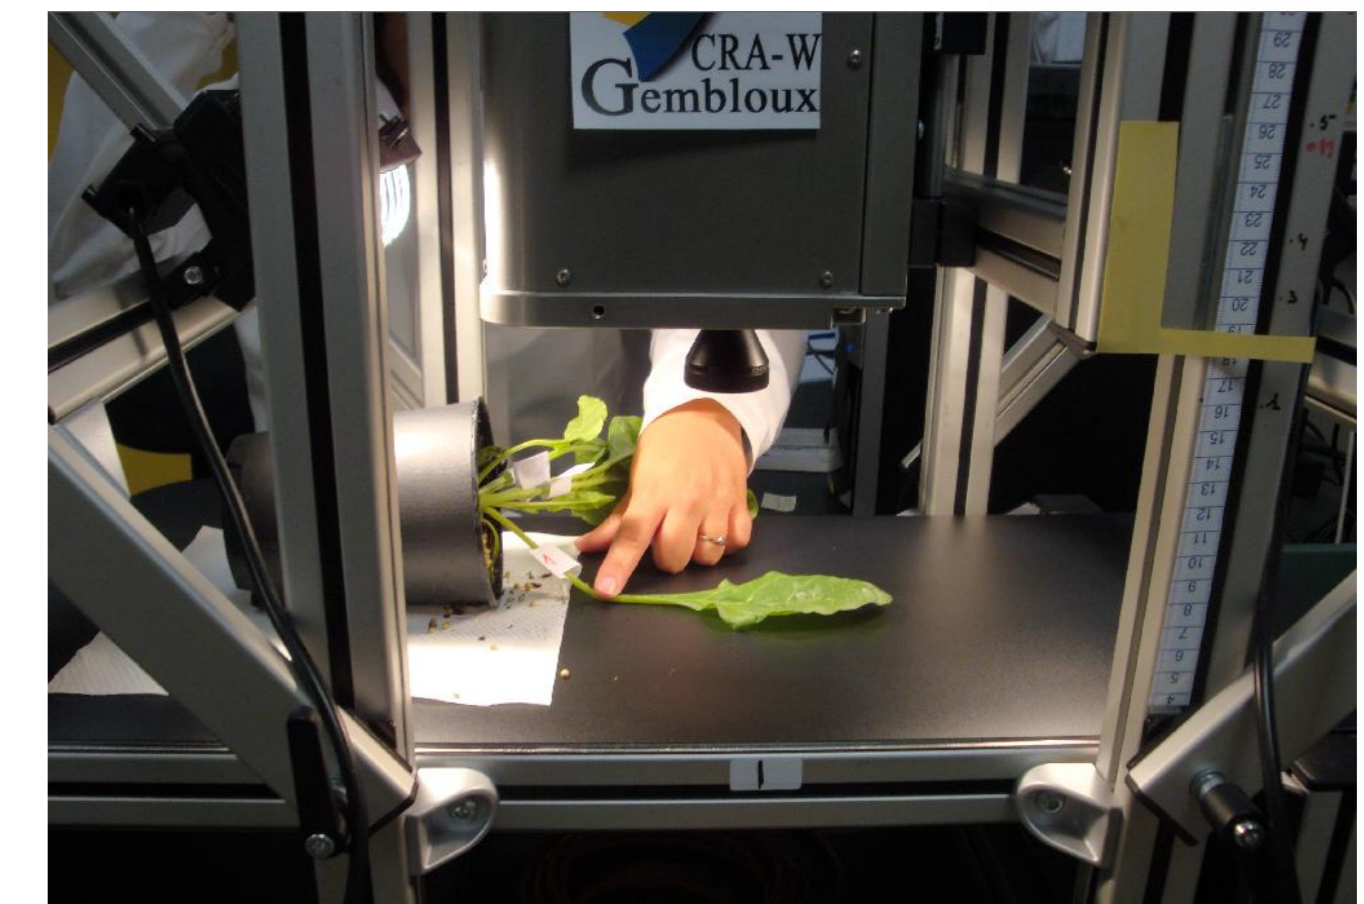
Figure 2: Image acquisition of sugar beet leaves using a line scan hyperspectral imaging system instrument.

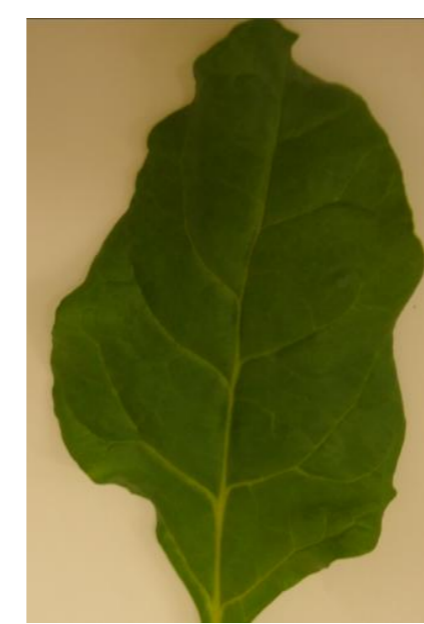
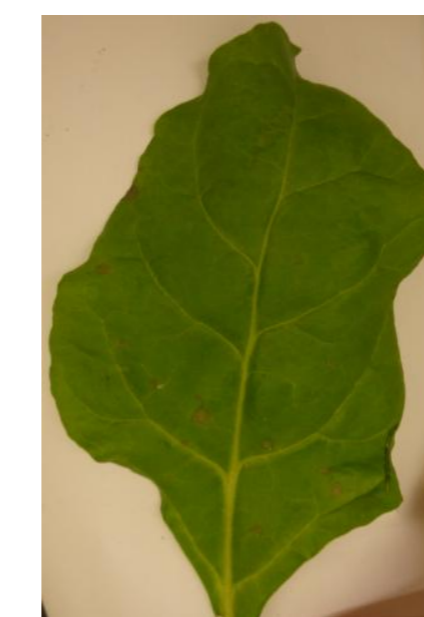
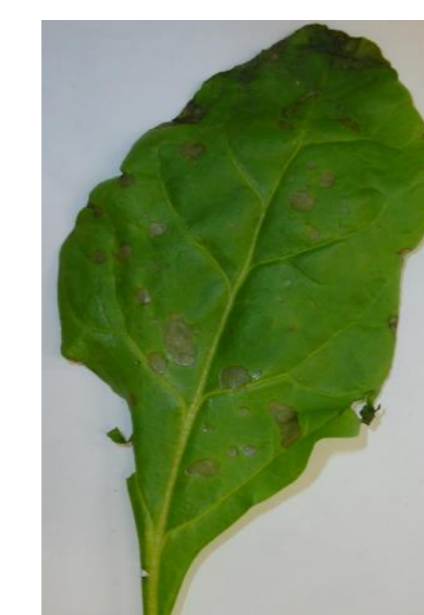
Figure 3: RGB picture, SVM and PLSDA results, showing the cercospora leaf spots observed at three dates (3 days before the first symptoms, the day of the first symptoms and 3 days after the first symptoms) on a leaf from a tolerant plant inoculated by spray with cercospora and analysed using the line scan hyperspectral imaging system.

For the necrotic area assessment, discrimination models were built using two spectral libraries corresponding to the cercospora leaf spots and the health leaves. Partial Least Squares Discriminant Analysis (PLSDA) and Support Vector Machines (SVM) were used as classification methods for the construction of these models. These models were applied to all the individual pixels in the images of the leaves in order to isolate and quantify the cercospora leaf spots. Figure 3 shows RGB pictures, SVM results using a program developed in Matlab and PLSDA results using the Hyperanalysis software (Burgermetrics) obtained by analyzing at 3 dates (6/8/2010, 9/8/2010, 12/08/2010) the same leaf from a tolerant plant (DQ100742-02) using the line scan hyperspectral imaging system. The data treatment using SVM model on each image consists of 3 steps (a to c). Figure 3a shows the image at 1000 nm. Figure 3b shows the pixels detected as health leaf or cercospora leaf spots after “background vs. leaf” equation application on the image of Figure 3a. Pixels corresponding to background (conveyor belt) are displayed in white color. Figure 3c shows the pixels detected as cercospora leaf spots after “health leaf vs. cercospora leaf spots” equation application on the not white pixels of Figure 3b. Pixels classified as cercospora leaf spots are displayed in black. The data treatment using PLSDA model shows in green the conveyor belt, in blue the health leaves and in red the cercospora leaf spots. As it can be observed, the cercospora leaf spots became detected by the discrimination models only when they are visually observed on the leaves.
